**MARYLAND HISTORICAL TRUST
DETERMINATION OF ELIGIBILITY FORM**

Property Name: Harmony Chapel Inventory Number: CE-1006
Address: Dr. Jack Road Historic district: ☐ yes ☒ no
City: Rowlandsville (Conowingo-mail) Zip Code: 21918 County: Cecil
USGS Quadrangle(s): Conowingo Dam
Property Owner: Maryland's Department of Natural Resources Tax Account ID Number: 027230
Tax Map Parcel Number(s): 261 Tax Map Number: 16
Project: DNR Historic Documentation of Razings Agency: Department of Natural Resources
Agency Prepared By: Historic Preservation Consultant
Preparer's Name: Catherine Masek Date Prepared: 1/21/2009

Harmony Chapel

Maryland Inventory of Historic Properties Form

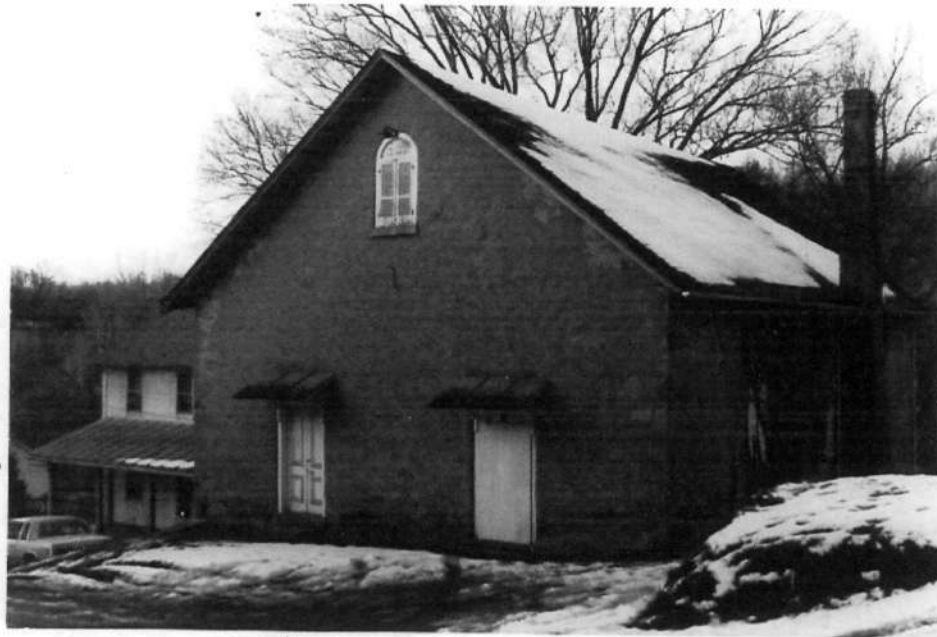
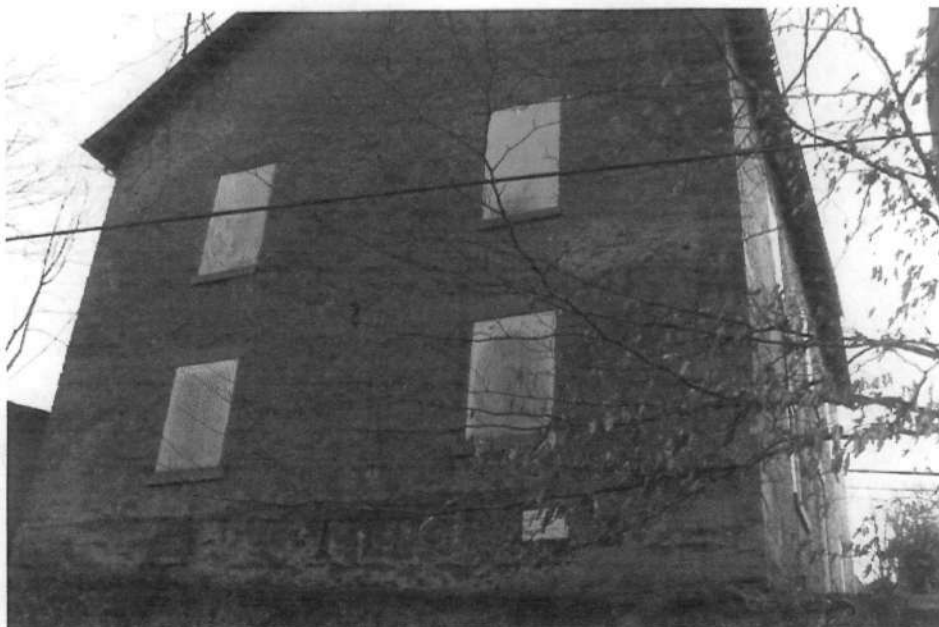
1984 FRONT (SOUTH) AND REAR (NORTH) FACADES
HARMONY CHAPEL, ROWLANDSVILLE
PHOTOCOPIES, MIHP FORM BY JOE GETTY

As the grade drops significantly from south to north, the building clearly displays a full basement level on the rear (north) façade. There are two original basement level window openings symmetrically balanced by two original first floor level windows on the rear (north) façade. Covered by plywood, the window openings repeat the same sill and lintel design. The basement level window sills are 6 feet above grade on this façade. Below the basement level, there is evidence of a

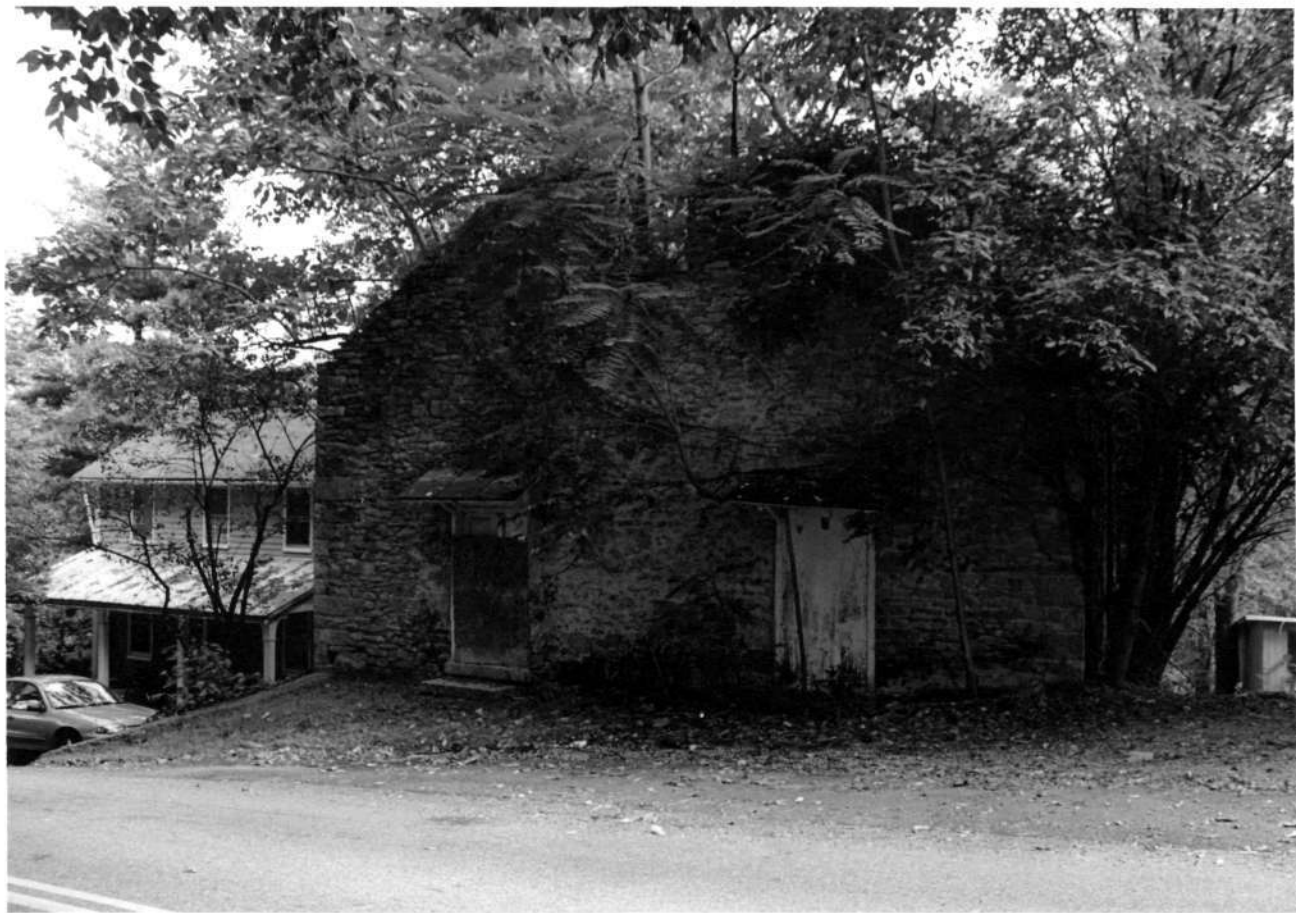
1 OF 6

The fieldstone church building, built 1870, is covered a light yellow tinted stucco coating that is in deteriorated condition, but best preserved on the front façade. The roof, once covered with asphalt sheets, now lies totally amidst the rubble in the nave. A chimney on the side (east) façade, which has been reconstructed of concrete block, stands intact. The four exterior walls (or shell) of the building remain intact. On the front (south) façade, there are two sets of double entrance doors, on stone sills, each accessed via a stone slab step. Each 4 panel door has original lock and partial knob hardware. Over each doorway is a transom, covered with a sheet of plywood. Above the transom of each entry is a shed roofed hood, covered with standing seam metal roof, diagonally braced with simple unadorned 2 x 4's. The roofline level window and date stone above the doors on the south façade is now totally missing, but photographs taken in the 1979 and 1984 surveys show its intact condition. Photocopies of these images are included within. This roofline window had a stone sill and simple wooden arched frame that at one time encompassed the inscribed date stone. Photographs show louvered shutters covering the opening, which obscured view of the window configuration. Photos of the roofline show deep eaves, with no cornice returns, and modern metal guttering and downspouts added to the side facades.

SOUTH (FRONT) FACADE

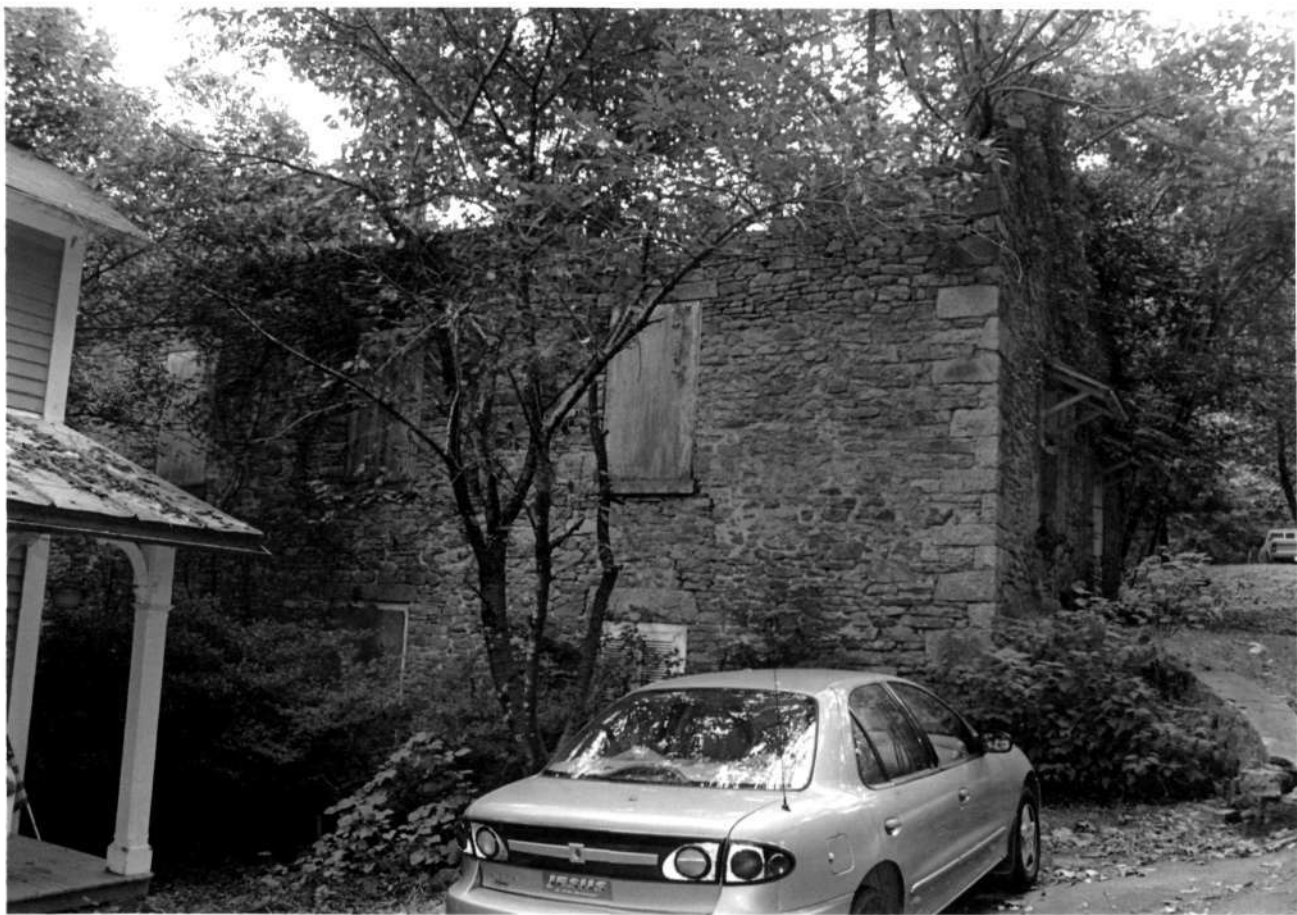
2 OF 6

The grade drops sharply to the west and north of the church building. On the downhill side (west) façade, is a basement level entry and two stories of boarded windows, all with roughly finished slightly projecting stone sills and flush stone lintels. A four foot wide stone walkway descends from the front of the building immediately beside the west façade to the basement level entry, where it ends. Due to the steep slope, there are 7 stone steps in the walkway. The doorway, covered by plywood on the exterior, is intact and visible on the interior. Similar to the front doors, there are two four-panel doors in the doorway, paneled jamb, and a 4 light (clear) transom. The west façade is three bays in width and a basement level window flanks each side of the doorway. Windows at basement level are covered with simple wooden vertically joined shutters. The basement level double hung window sash, partially evident from the interior, contains 6 lights above the meeting rail, but an interior view of the lower sash at basement level is obscured by debris and tree growth. Windows at first floor level are all covered with exterior plywood sheets, but their openings were historically filled with stained glass windows donated by local families in memory of deceased relatives. (Ralph Hostetter, telephone interview, 1/09) Three first floor window openings are located directly above each basement level window opening on the west facade. The only window remaining in situ and still evident is the west façade first floor stained glass window above the basement entry doors. Twisted and bulging in its frame, its existence may be short lived. Metal reinforcing rods, with S-shaped end pieces are clearly evident on this façade. The typical size of basement level windows is 46" x 24", while first floor level windows are typically slightly larger- 78" in height.

WEST (SIDE) FACADE

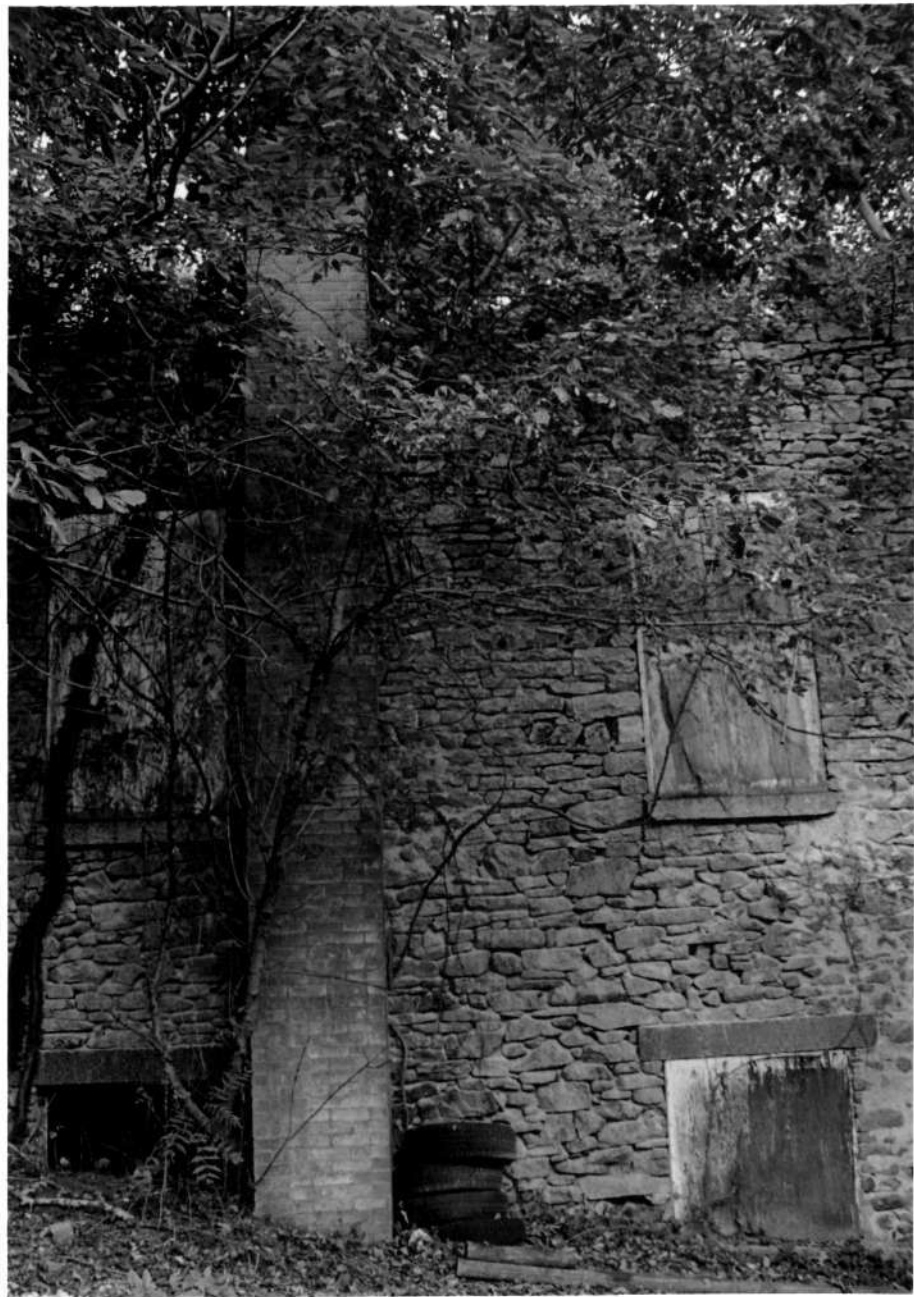
3 OF 6

The uphill side (east) façade is three bayed, and mirrors the openings on the west façade. There are only two basement level windows on the east façade, due to the grade, and they are small, but open/ exposed to the elements and collapsing. Garbage has been emptied to the interior via the northeast window. A tan concrete block chimney flue, 20th century alteration, stands north of and next to the center bay window. An oil tank entry pipe is located immediately south of the left bay. Trees grow randomly and freely immediately adjacent to the east façade, as they do at all facades.

EAST(SIDE) FACADE

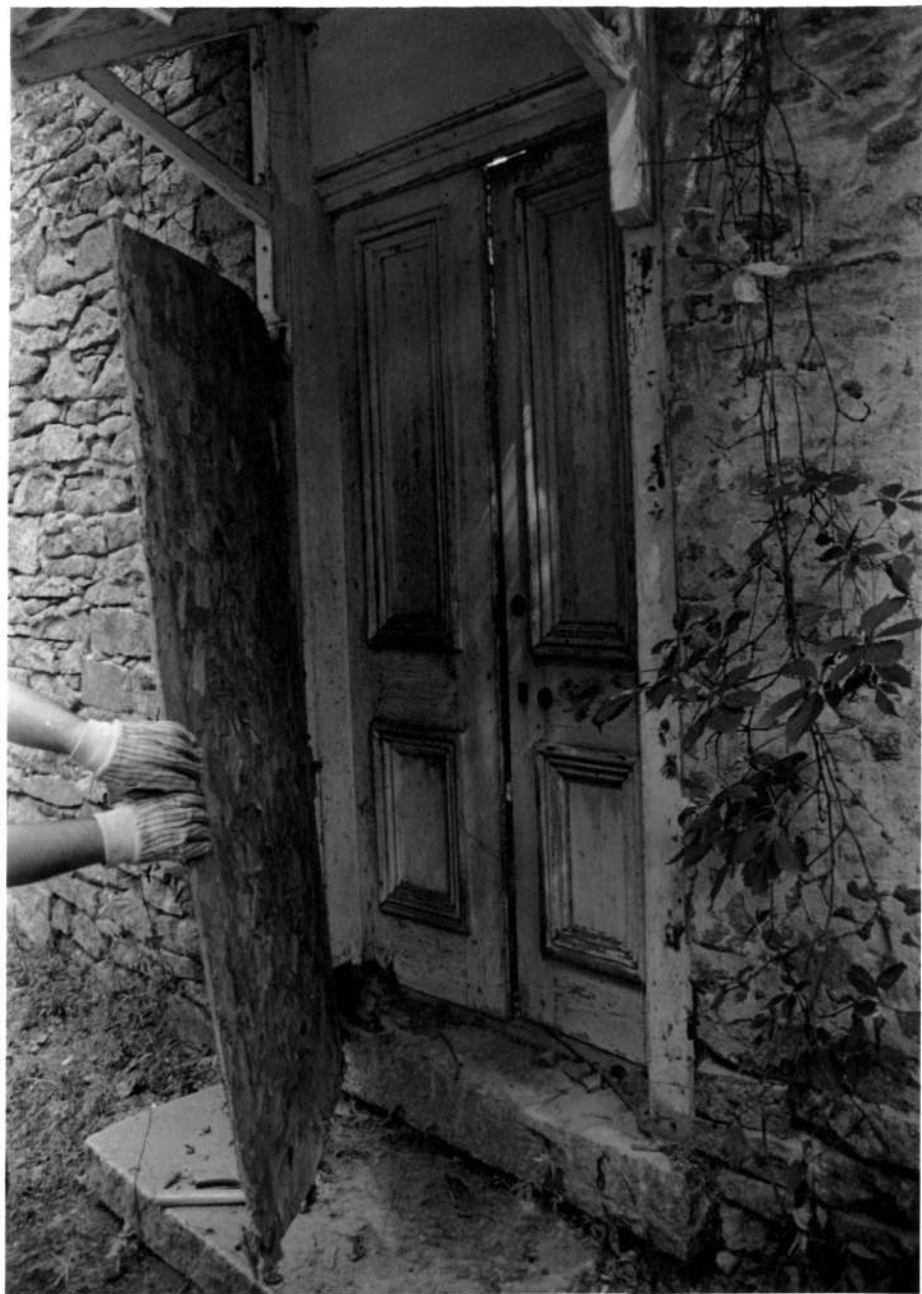
4 OF 6

WESTERMOST ENTRY-SOUTH (FRONT) FACADE

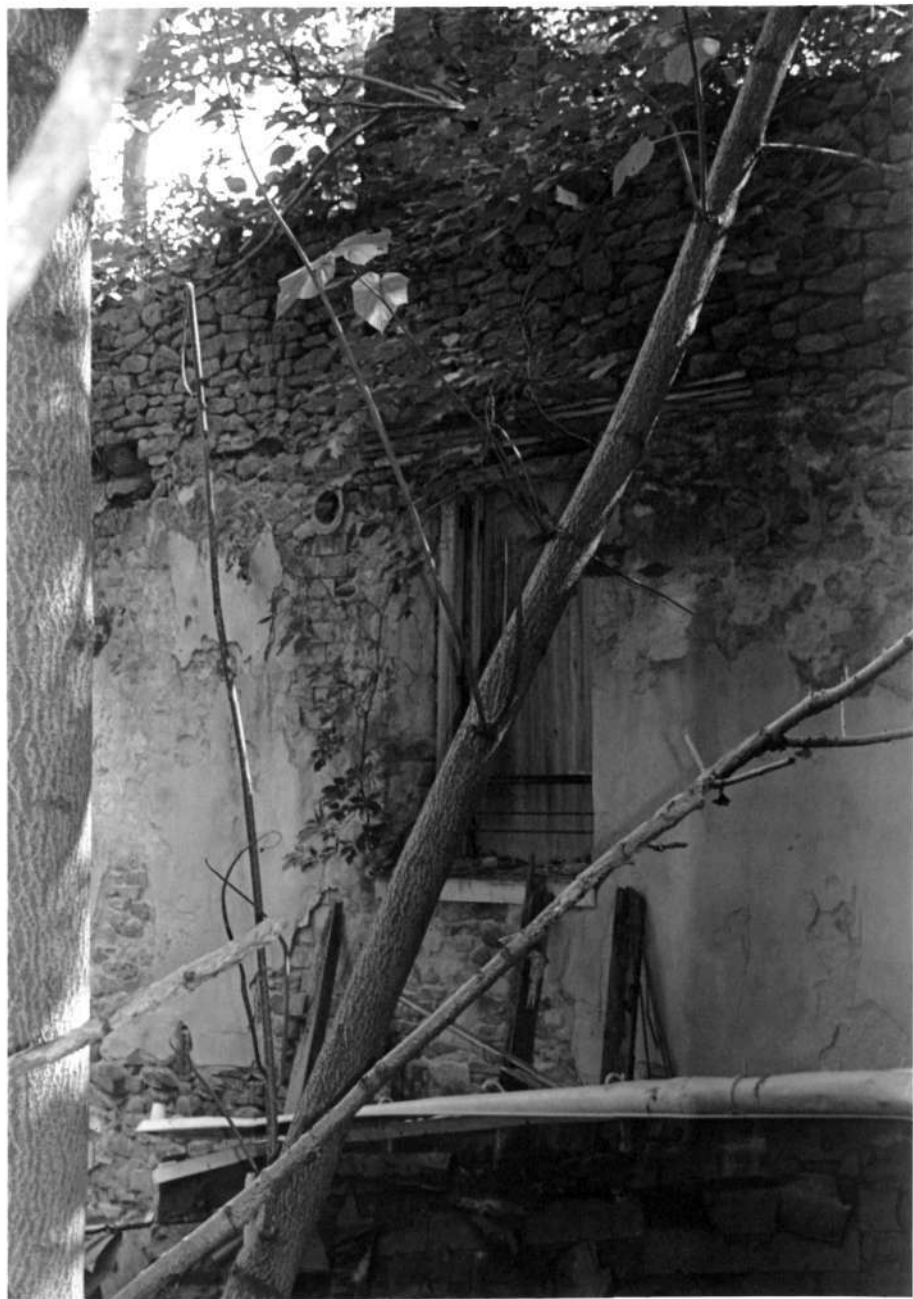
5 OF 6

The interior is no longer accessible. In 1984, when an updated survey was completed, it was apparently possible to enter via the west entry door. The basement level is completely full of household debris, tree trunks, and garbage bags that have been disposed of via basement windows. The interior is completely open to the elements, the roof is 100% collapsed, as are upper portions of all exterior walls. The front (south) doorways provide viewing access to the interior from their sills. Fragments of baseboard, paneled door jambs, parts of windows and shutters are all that remain of the interior woodwork. First floor flooring no longer exists on the interior and one cannot venture beyond the door sill. An off white plaster like coating covers the interior stone walls; no painted wall designs are evident. There is one stained glass window in the west wall, but no church furniture evident amidst the debris. The 1979 survey form describes a more complete interior: There was "Victorian style trim around the altar and sanctuary. The altar had painting in arches above patterned glass windows of one over one sash. There was a wood paneled altar and alter rail, with a cut out pattern enclosing the altar. There are also several pews in the structure which show serpentine-shaped carved arms with floral motif." While no images could be located showing the interior, there is first hand recollection by a long time parishioner of a painted mural that was located behind the pulpit (altar area) entitled: "Christ at the Door." There is no mention of such a wall painting in either the 1979 or 1984 MIHP forms, so the possibility exists that the mural was overpainted due to the rising damp, which was discussed in the MIHP forms. Interior lighting fixtures have been removed by Susquehanna State Park employees and placed in storage in the Susquehanna State Park Maintenance complex on Wilkinson Road. Black and white images and color slides are included herein of those late 19th century bronze finished wall sconces and chandelier. Trees growing freely and randomly on the interior include: approximately eight Powlania trees, each 30-40 feet in height and 12" in diameter and approximately four birch trees, each 30-40 feet in height and about 8" in diameter,

INTERIOR-EAST WALL

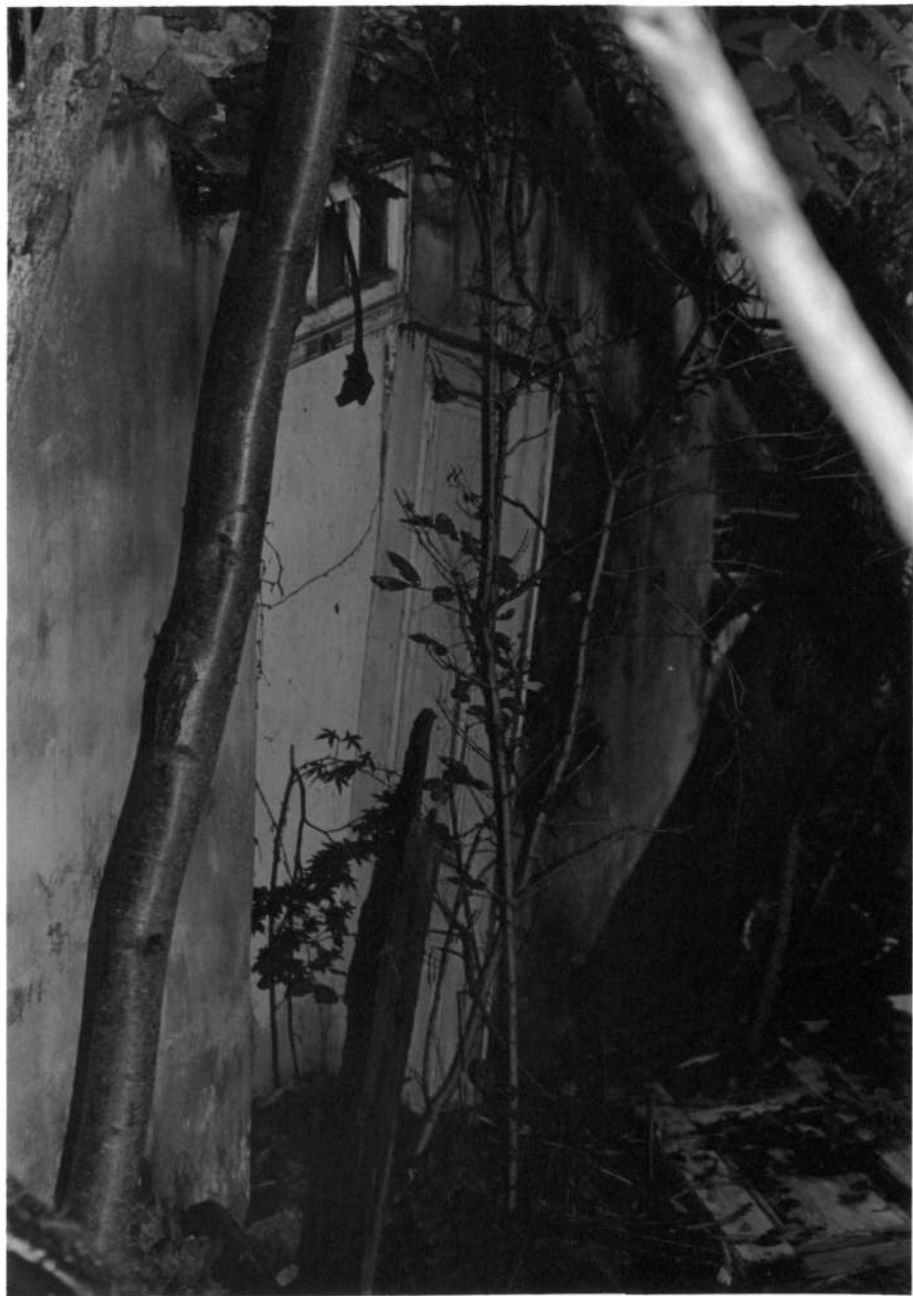
The interior of the Old Harmony Methodist Church has collapsed into the basement of the structure. From the foundation level entrance on the west facade, one can view the remains of the interior of the structure. The church had Victorian-style trim around the altar and sanctuary. The altar had painting in arches above patterned glass windows of one-over-one sash that are intact. There was a wood paneled altar and an altar rail with a cut-out pattern enclosing the altar. There are also several pews in the structure which show serpentine-shaped carved arms with floral motif.

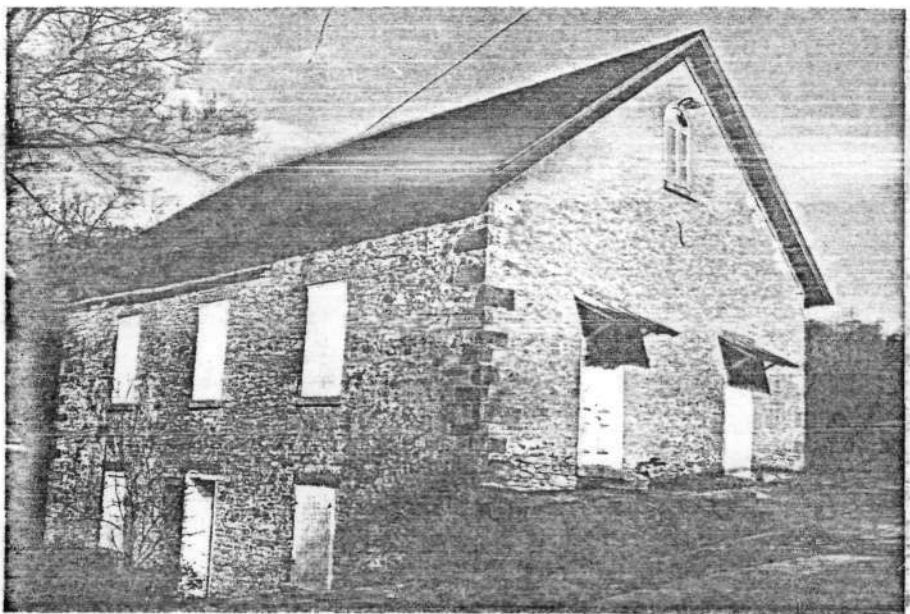
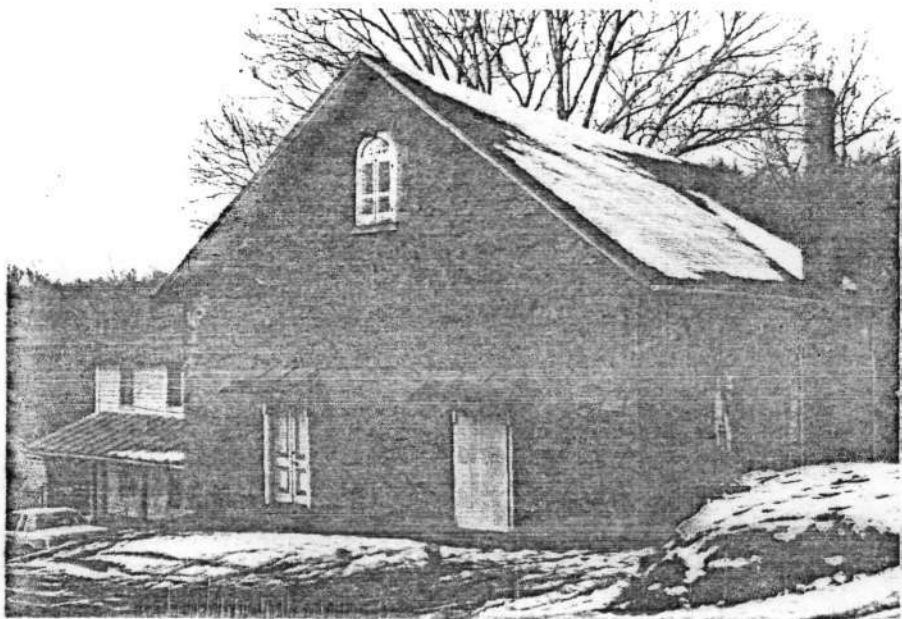
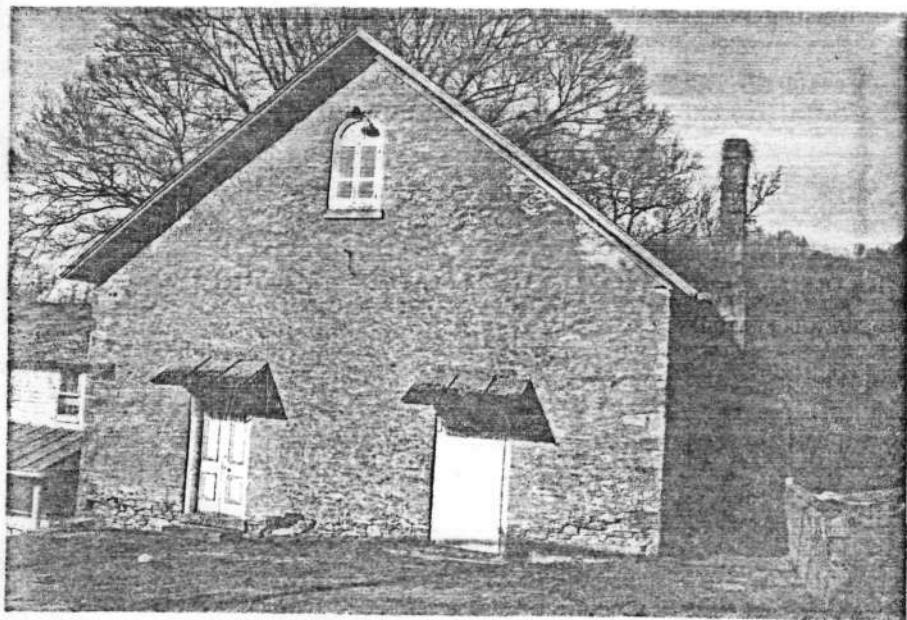
CE 1006 Harmony Chapel
 top - South & West Facades
 center - South & East Facades
 bottom - South Facade

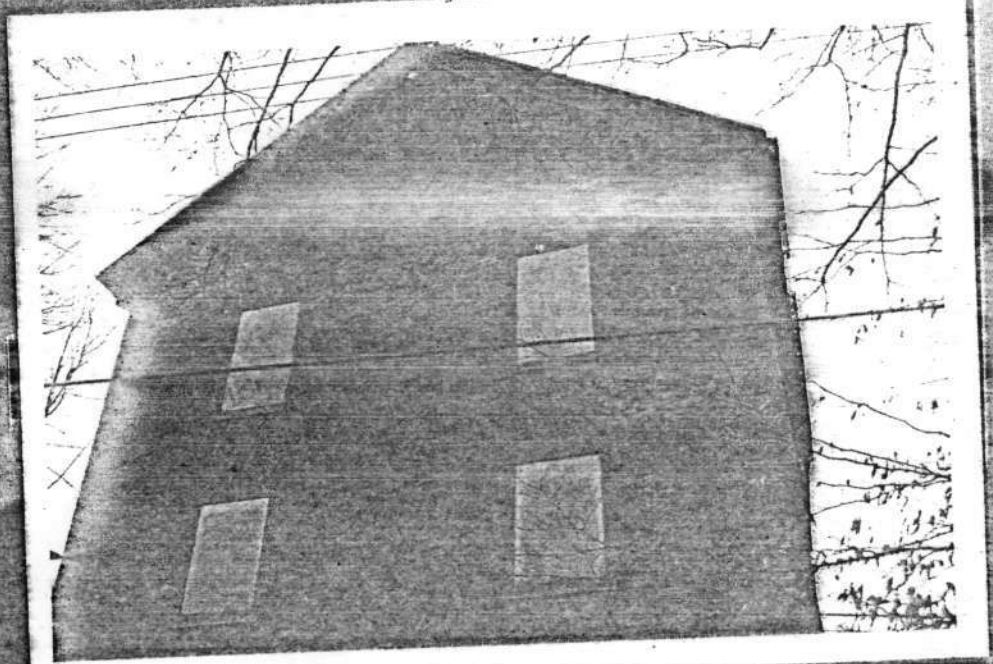
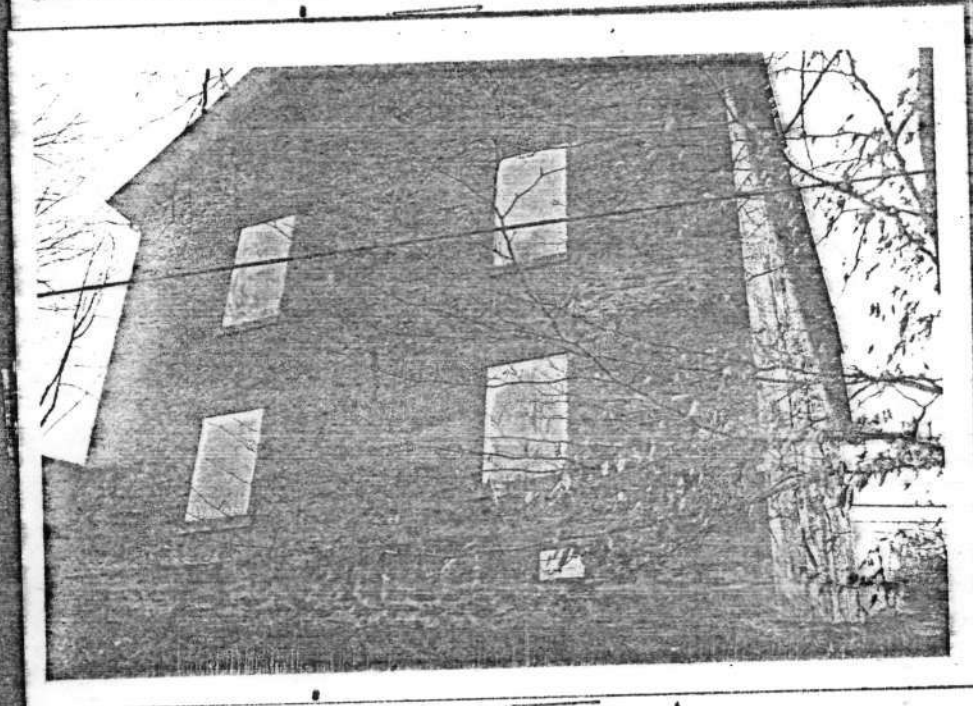
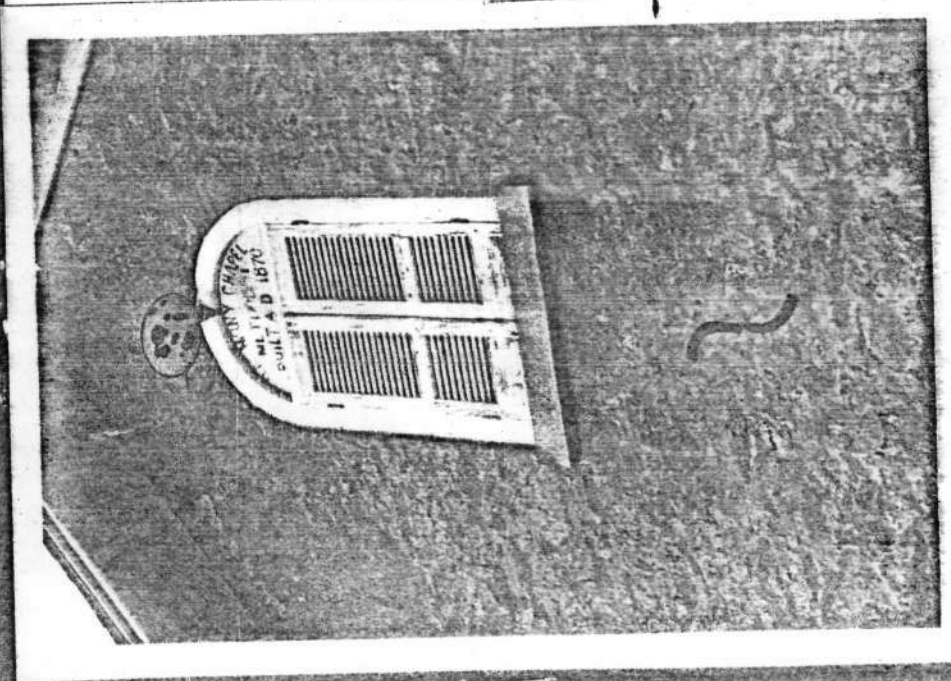
top - North Facade

center - North Facade

bottom - South Gable - Dated Window

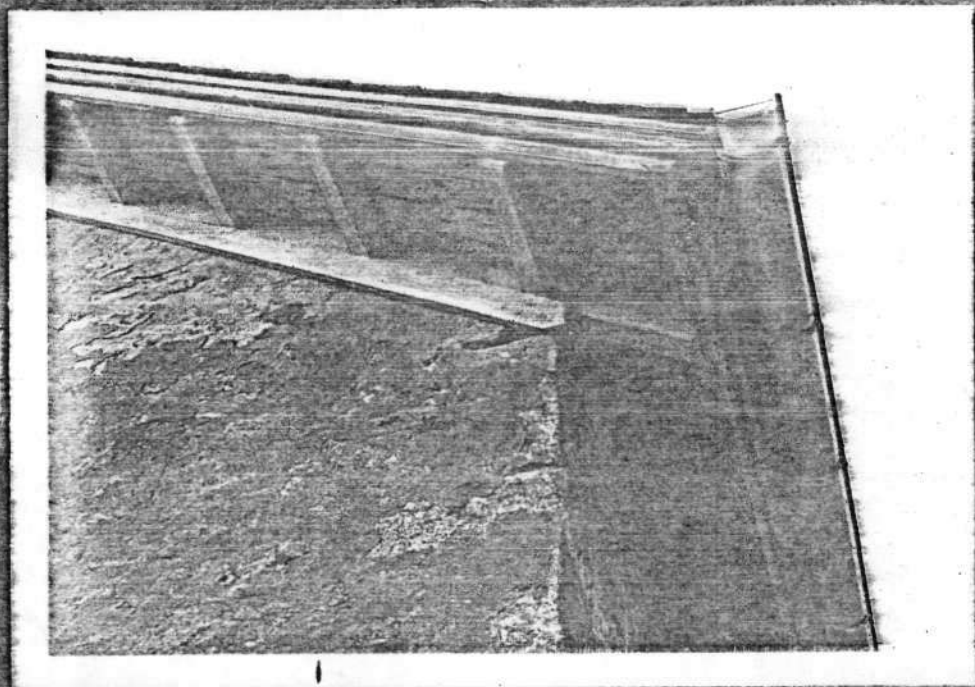
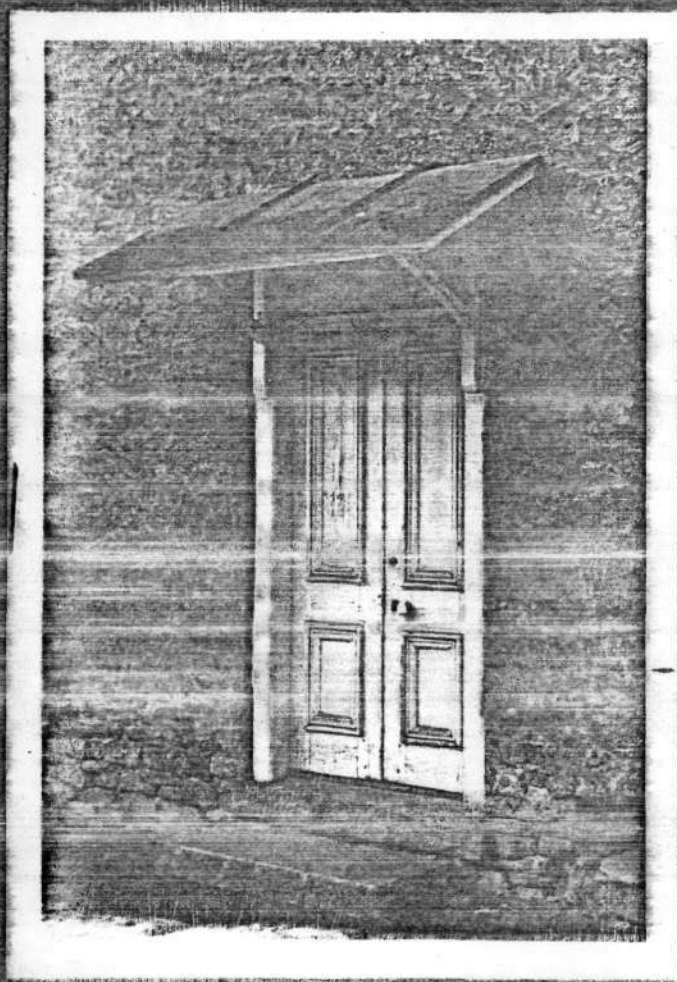
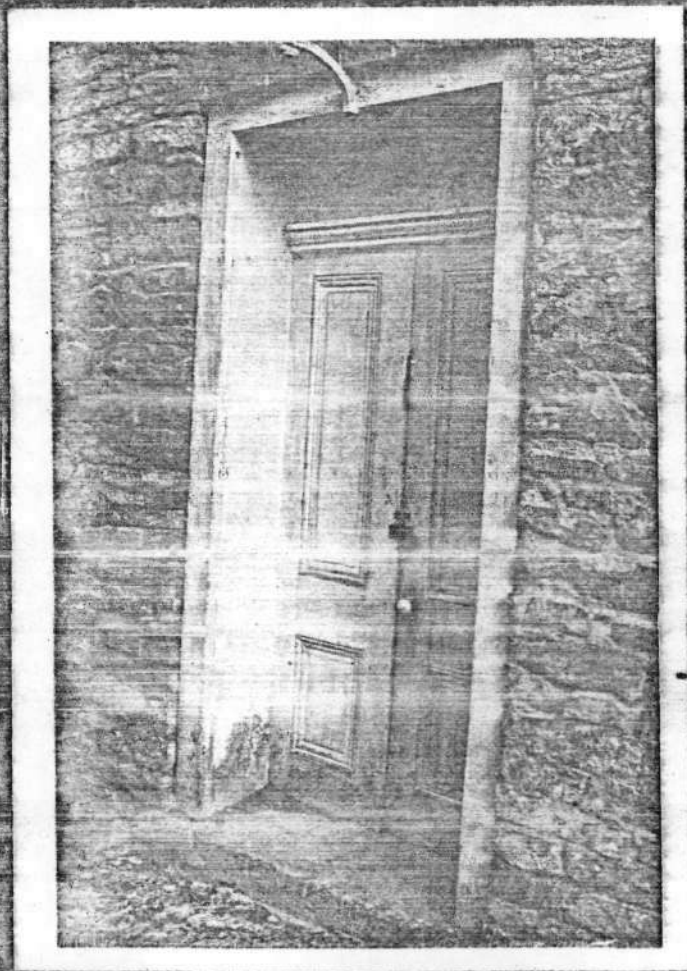
CE 1006 Haurmy Chapel
top - Southeast Corner, Cornice
bot. left - South Facade, west Double Door
bot. right - West Facade, Double Door

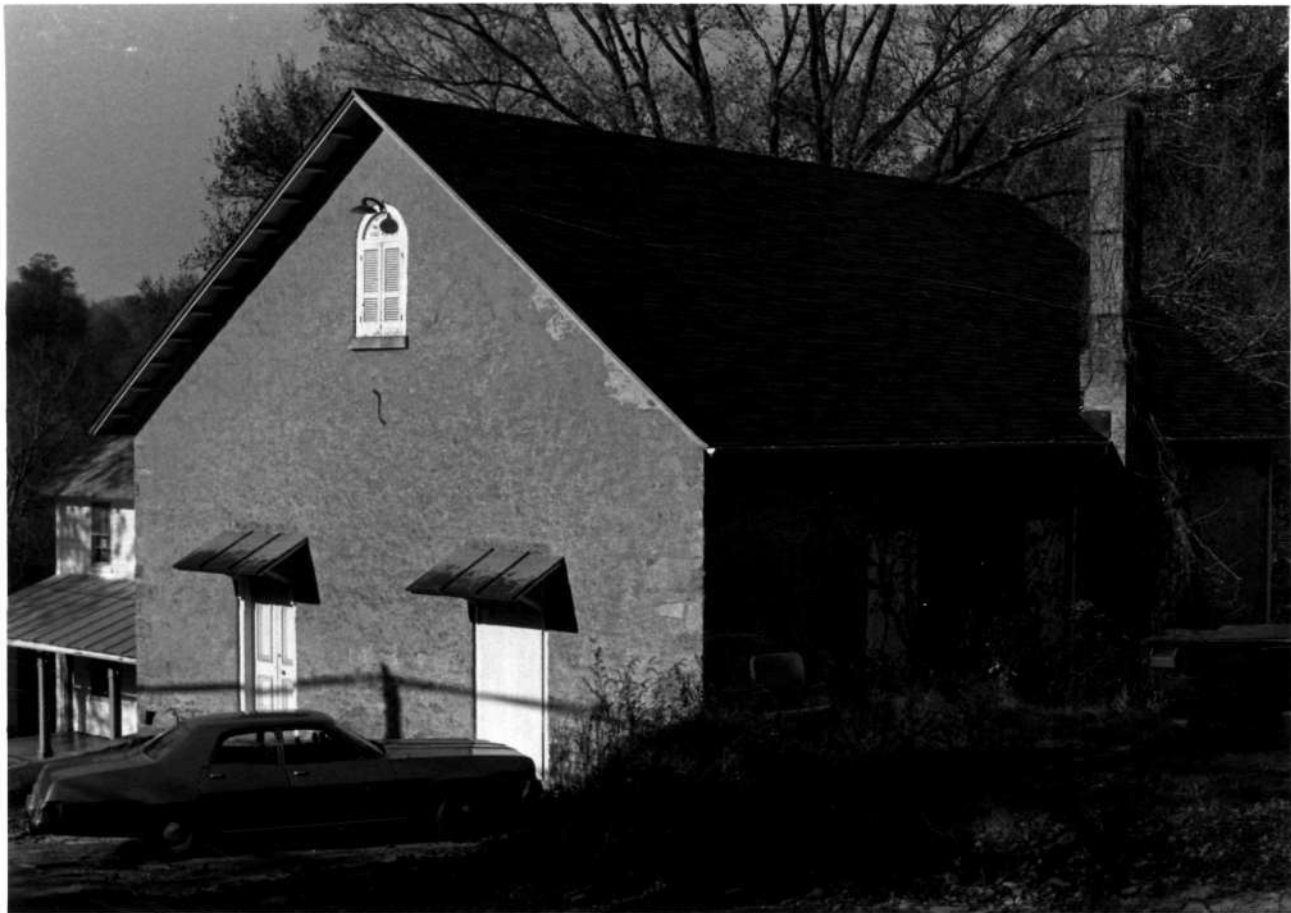
Harmony Chapel
Rowlandsville
(Susquehanna State Park)
southeast elevation
B. Deale 11/78

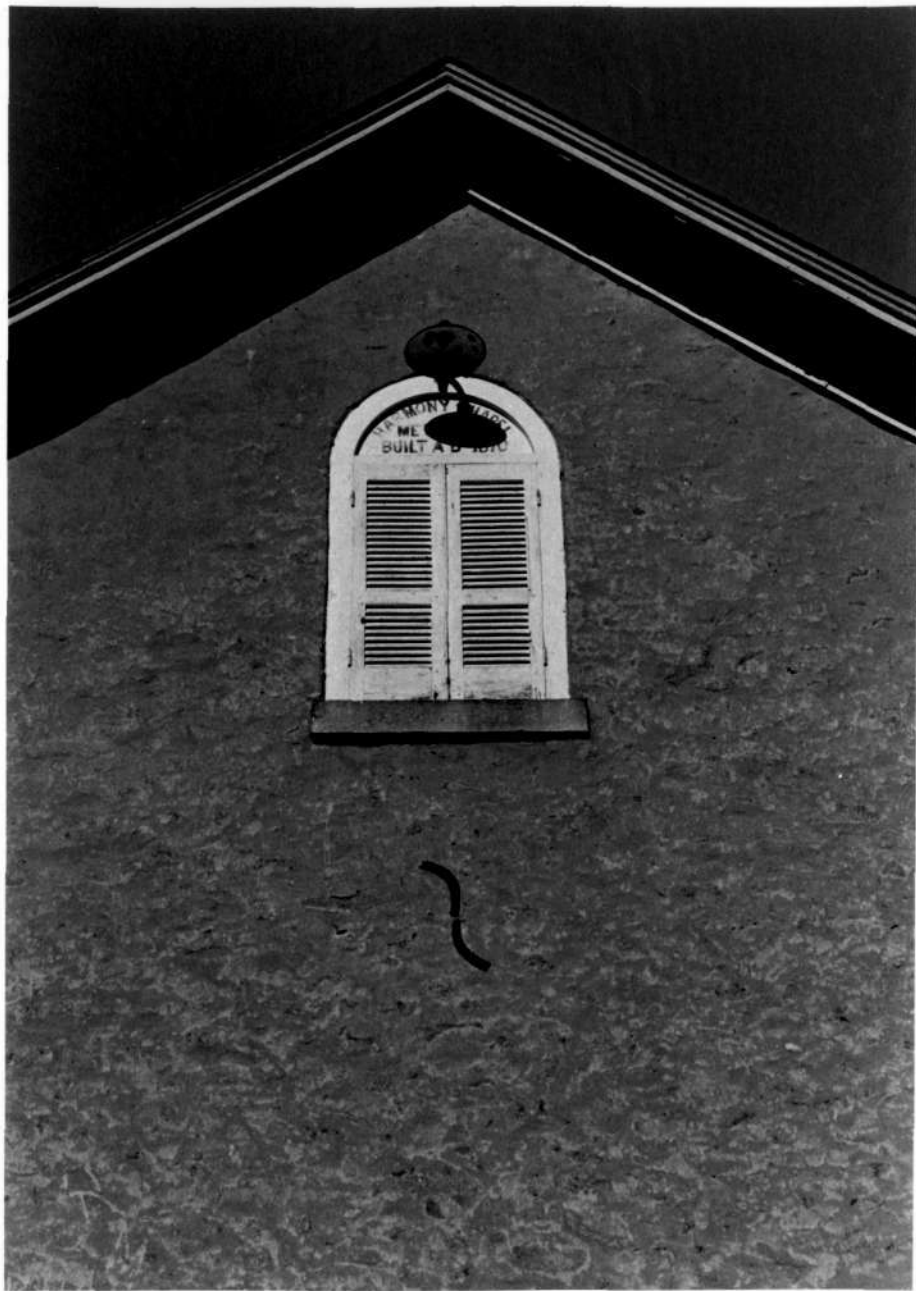
Detail: south gable
E. Coxe/B. Deale
